Midwest Home and Property Inspection

CONFIDENTIAL INSPECTION REPORT

1005 Sycamore Dr
Maysville, MO 64469

11/11/2025

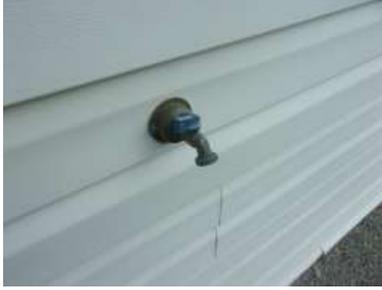
Hose Faucets: Exterior hose faucets did not work at the time of the inspection

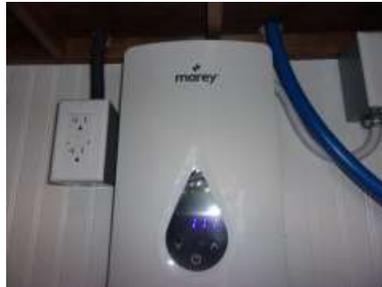
The temperature did not get very hot with just one faucet on and dropped to just a warm temperature when two were on at the same time. Recommend evaluation and any needed repairs by a certified contractor.

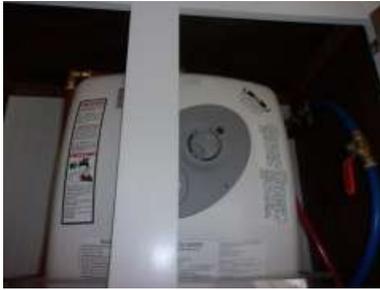
The unit did not respond to normal controls. Recommend evaluation and any needed repairs by a certified contractor.

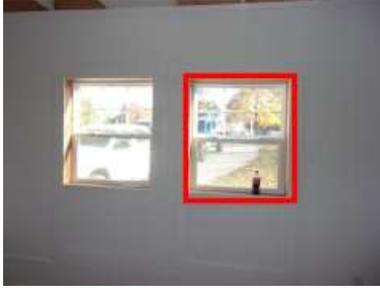
Window Conditions: **The window locks will not engage. Recommend evaluation and any needed repairs by a certified contractor.**

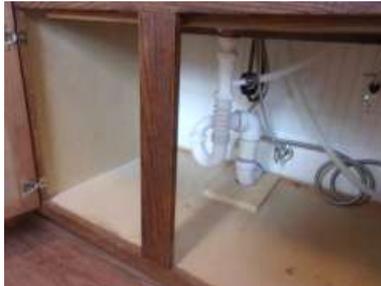
The sink drain includes a flexible drainpipe. Such piping is not a approved as plumbing material and can easily lead to blockages. We recommend replacement of the pipe with an approved plumbing pipe.

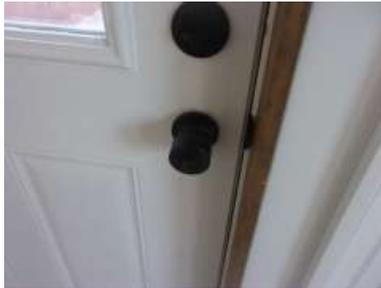
The door to the outside knob is loose and should be repaired.

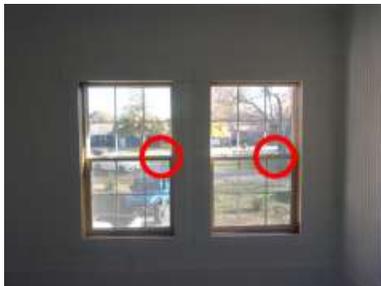
The window locks will not engage. Recommend evaluation and any needed repairs by a certified contractor.

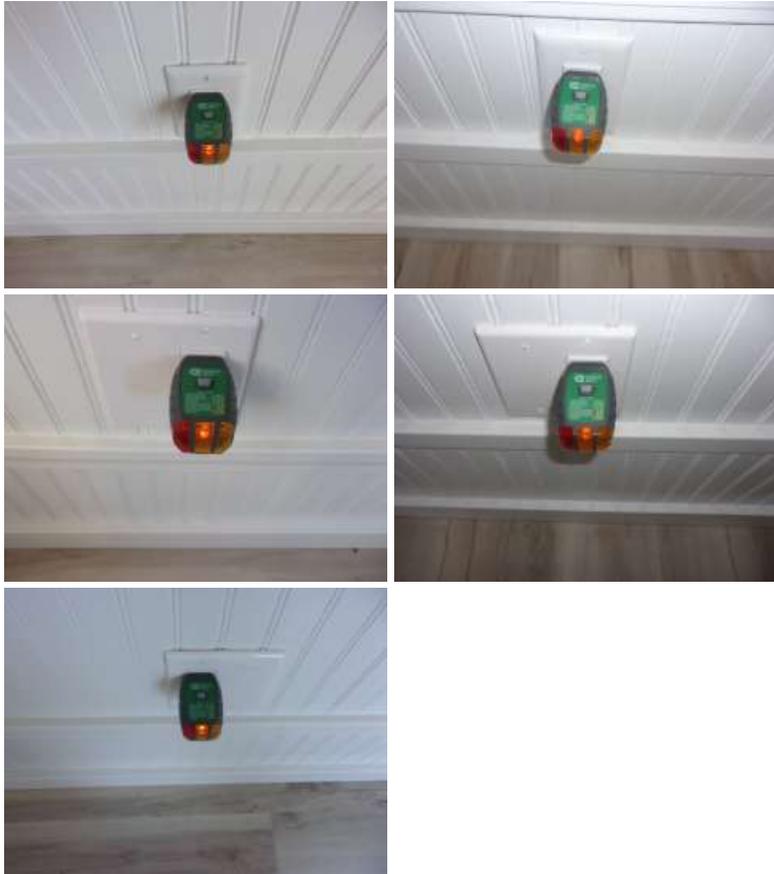
Multiple three prong outlets have an open ground. Recommend evaluation and any needed repairs by a certified contractor.

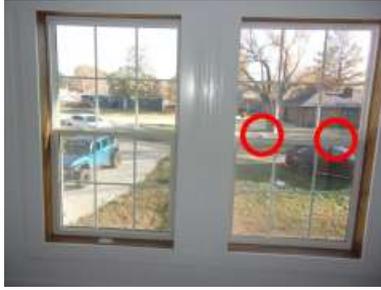
Window Conditions: The window locks will not engage. Recommend evaluation and any needed repairs by a certified contractor.

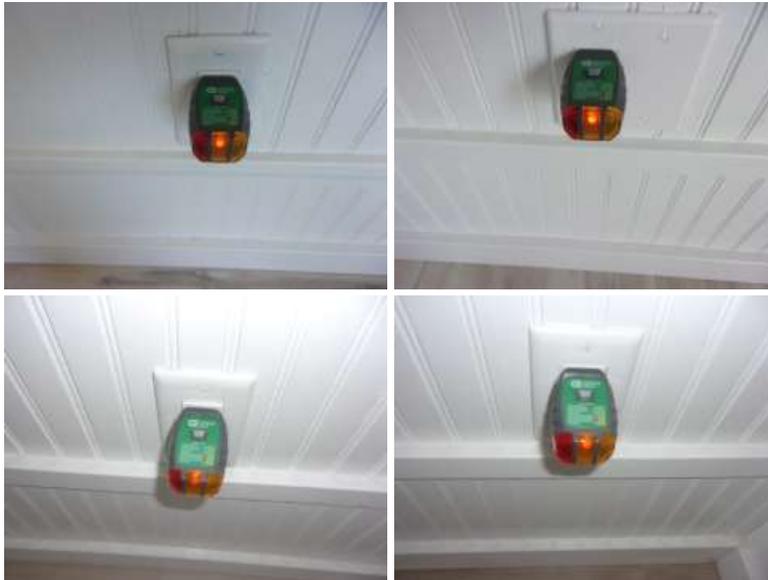
Outlets: All of the three prong outlets in this room have an open ground. Recommend evaluation and any needed repairs by a certified contractor.

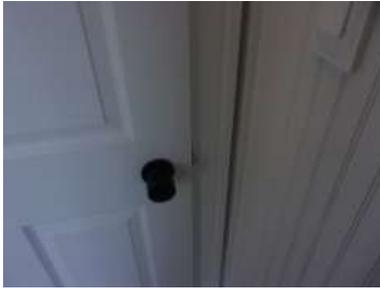
The door rubs on the frame. Recommend evaluation and any needed repairs by a certified contractor.

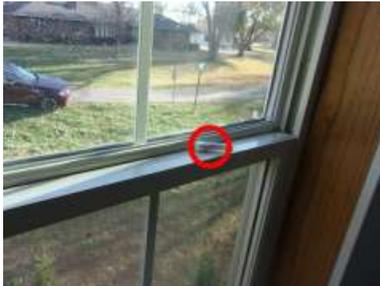
The window locks will not engage. Recommend evaluation and any needed repairs by a certified contractor.

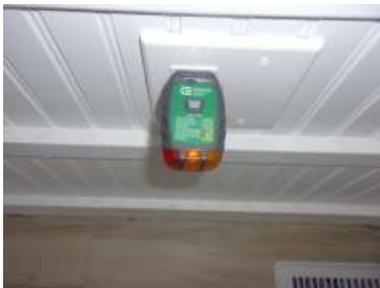
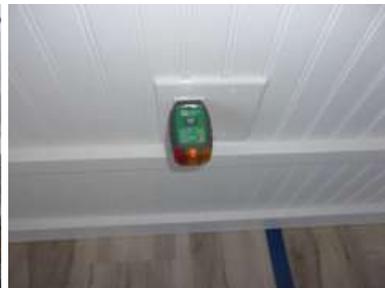
All of the three prong outlets in this room have an open ground. Recommend evaluation and any needed repairs by a certified contractor.

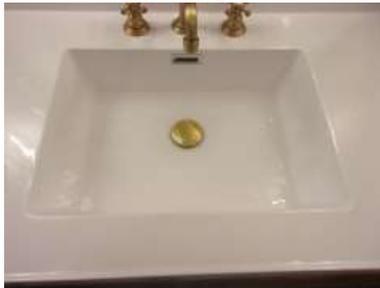
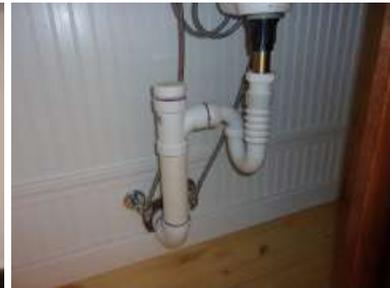
The sink drain includes a flexible drainpipe. Such piping is not a approved as plumbing material and can easily lead to blockages. We recommend replacement of the pipe with an approved plumbing pipe.

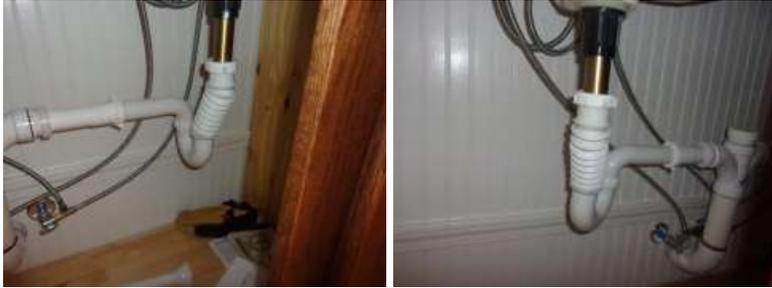
Location: Second Floor. Northwest corner.
Size: This is a full bathroom.
Doors: The door in this room is functional.
Flooring: The floor has no significant defects.
Walls and Ceiling: The walls and ceiling are in acceptable condition.
Sink(s) and Drainage: **The sink drain includes a flexible drainpipe. Such piping is not a approved as plumbing**

material and can easily lead to blockages. We recommend replacement of the pipe with an approved plumbing pipe.
